INVESTIGATION REPORT

August 13, 2012

Shell Oil Products US Martinez, California Refinery Fire at Hydrocracker J-97 Hydrogen Compressor

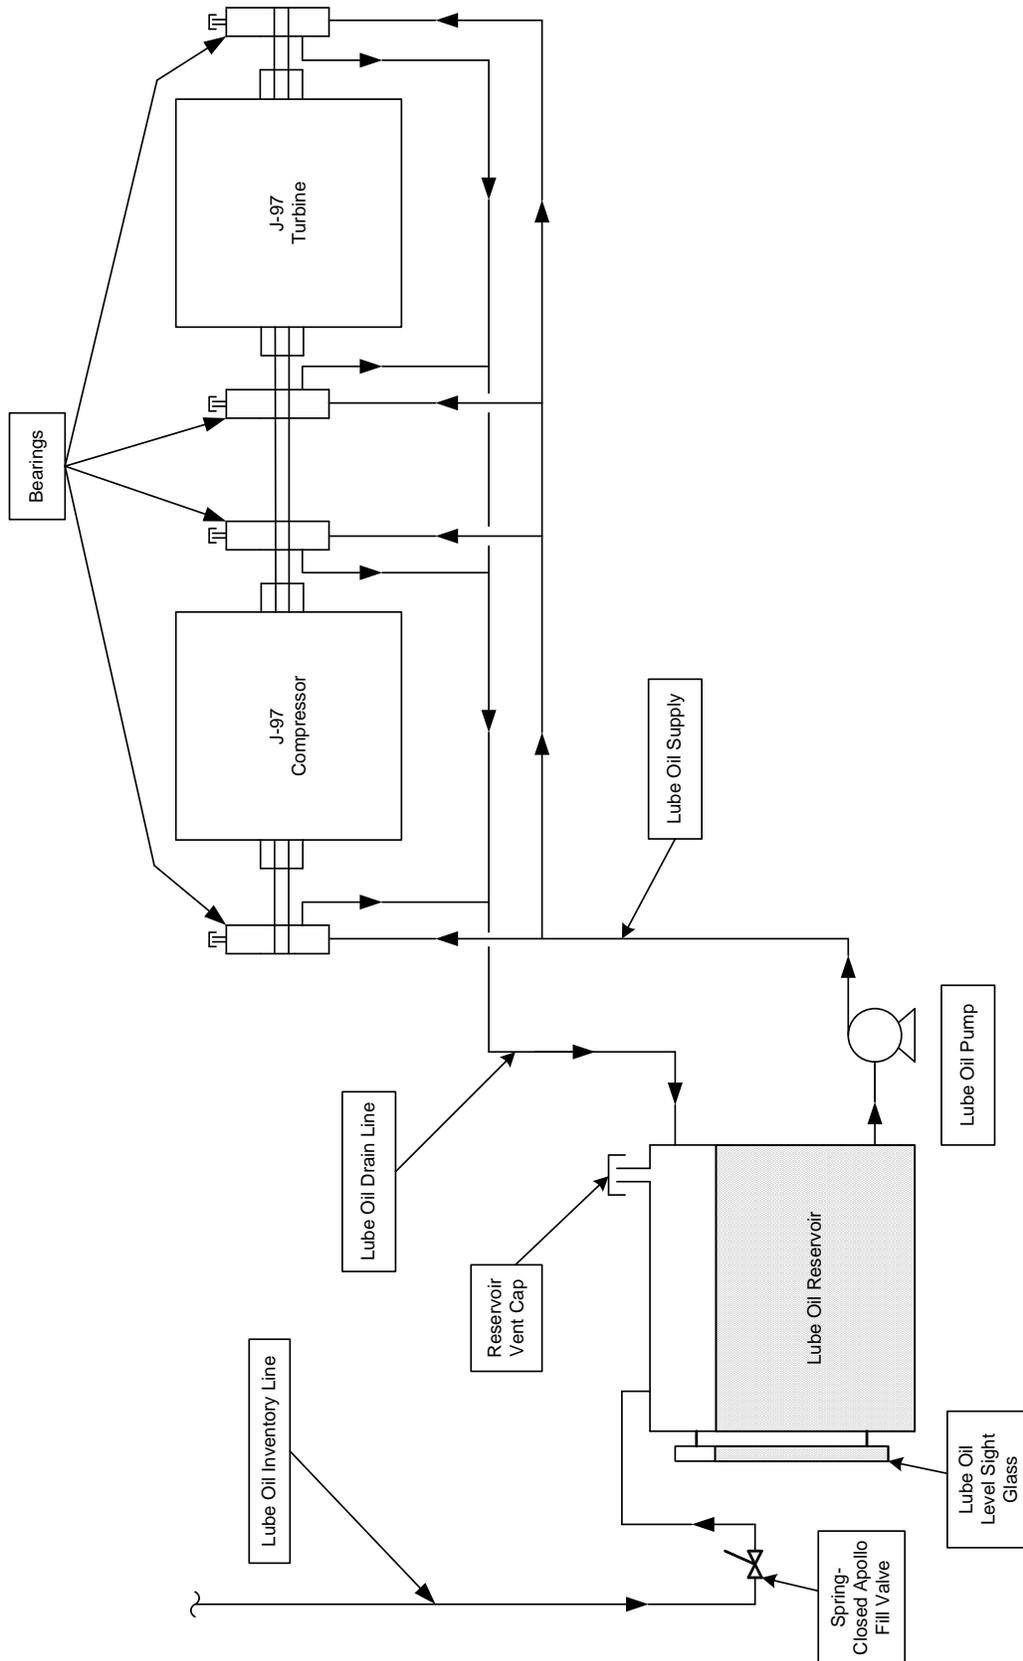
Attachment A – J-97 Reservoir Diagram

The source of the oil was the compressor lubrication system. The lube oil reservoir fill valve has a spring return-to-close mechanism, but that device had been defeated so that the valve was in the open position. The open valve was left unattended while the reservoir was filling. The reservoir began to overflow out the vent valve on top of the reservoir, and then flowed to the ground. This created a pool of oil near the compressor, but is not believed to have ignited because there are no heat sources close enough to grade. After the initial fire broke out, this oil ignited and caused a secondary pool fire beneath the compressor.

Once the reservoir was full, the liquid flow out the vapor vent was less than the flow of oil being pumped to the compressor and returned in the gravity drain line. This created an imbalance in flows that resulted in buildup of oil inside the compressor. The excess lubricating oil escaped the compressor, most likely from the bearing seal at the end of the turbine shaft. A small section of shaft is exposed, and fire damage evidence suggests that the excess oil was sprayed by the rapidly rotating shaft onto the nearby case and 650 psig steam piping. The required oxygen, fuel and heat were all present at that point to start the fire.

LCC-3: The system was not designed to include a liquid vent, only vapor vent. This contributed to a restriction, preventing lube oil from draining back to the reservoir, which allowed oil to escape at the compressor and ignite.

Cause	Recommendation	Responsible Manager or Individual	Estimated Completion
LCC-1	1. Provide awareness level training to Operations that describes this event and explains how overfilling a lube oil reservoir can lead to a fire.	Production Unit Manager	12/31/2012
LCC-2	2. Review ergonomics of the reservoir filling operation for opportunities to reduce discomfort on longer filling operations.	Production Unit Manager	6/30/2013
LCC-3	3. Review the reservoir design for the liquid overflow scenario. Consider design alternatives that allow excess liquid oil to overflow to a safer location instead of escaping at the compressor, or instrumentation or controls that would reduce the risk of overflow.	Production Unit Manager	6/30/2013

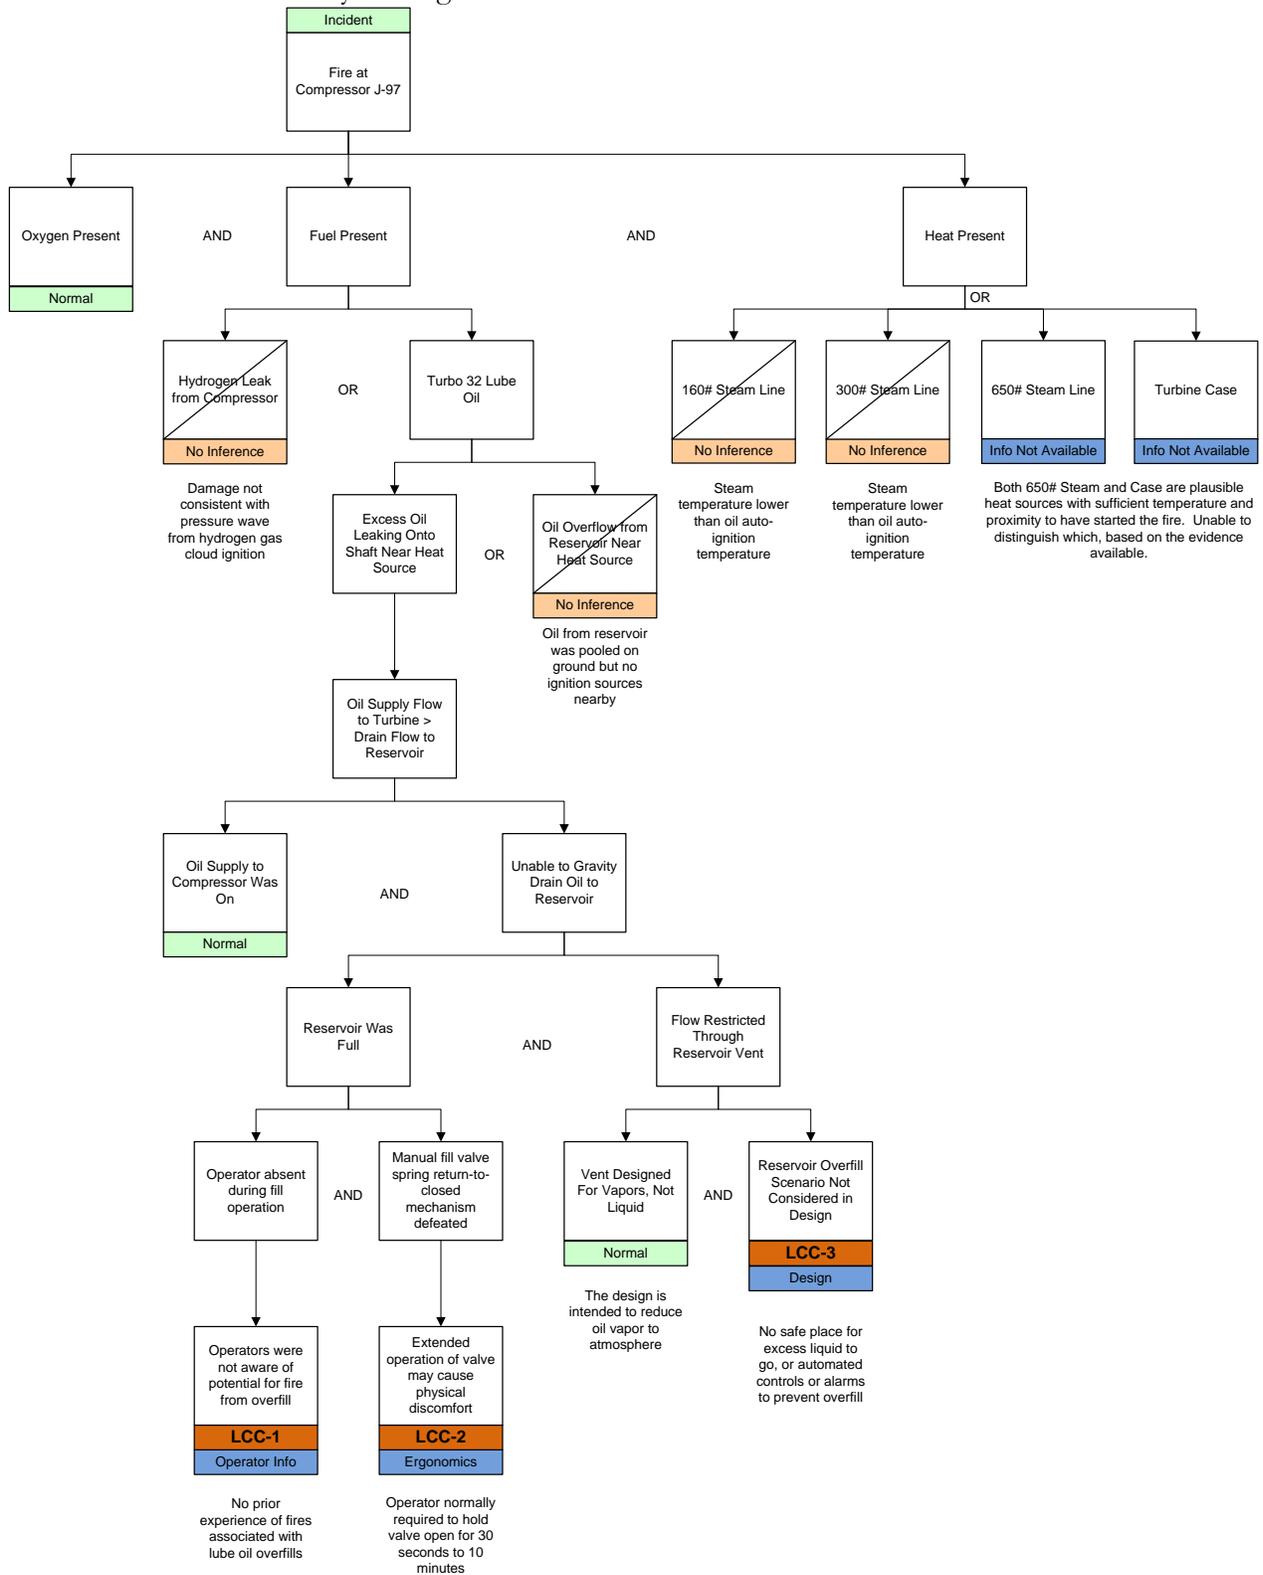
Attachment B – Fault Analysis Diagram

The root cause of the incident is that the operator left the oil reservoir while it was filling, which led to overfilling the oil reservoir and restricting of the oil return line.

LCC-1: Workers understood the general hazards of materials and conditions, but were not aware that overfilling the lube oil reservoir could lead to a fire.

LCC-2: Some physical discomfort may be experienced while refilling the lube oil reservoir because the valve must be manually held in the open position for a variable amount of time, typically 30 seconds to 10 minutes. This discomfort may lead to operators using auxiliary means to keep the valve open, which negates the purpose of the spring return mechanism.
