**Subject: Root Cause Analysis Report for the July 19, 2018 3HDS Water Injection Piping Failure Vapor Release**

**Root Cause Analysis Report  
Tesoro Martinez Refinery  
July 19, 2018 3HDS Water Injection Piping Failure Vapor Release**

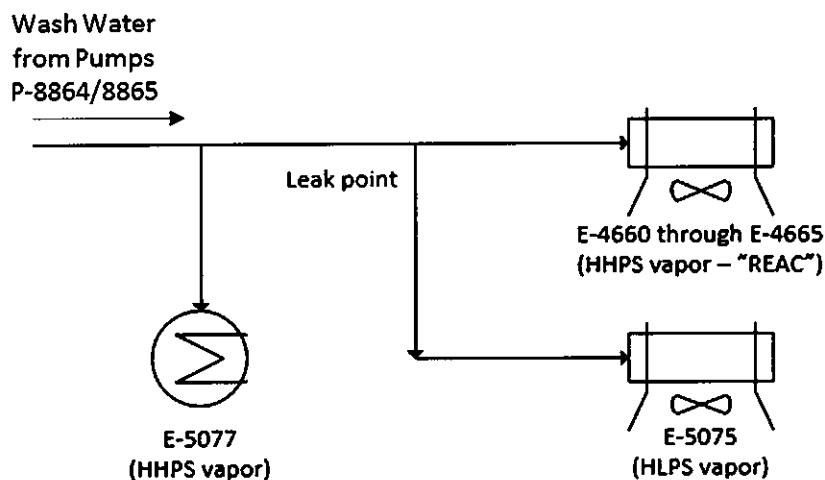
Simplified process flow of Wash Water piping system

Demineralized water and clean condensate are supplied to 3HDS and pumped up to approximately 1850 psig. Wash water is typically injected at a rate of 95-115 GPM to the Reactor Effluent Air Coolers (REACs) and 20 GPM to Exchanger E-5075. Every week, water injection is routed to E-5077, which sits immediately upstream of the REACs. To obtain the needed pressure for water injection into E-5077, isolation of both the REACs and HLPS Air Coolers is required. This weekly intermittent water wash removes deposited salts from E-5077 and maintains heat transfer performance. Intermittent water washes
